# intel® Technical Advisory

TA-0745-01

January 18, 2005

## Missing Power Cable in Tape Drive Kit for Intel Server Chassis SR2400

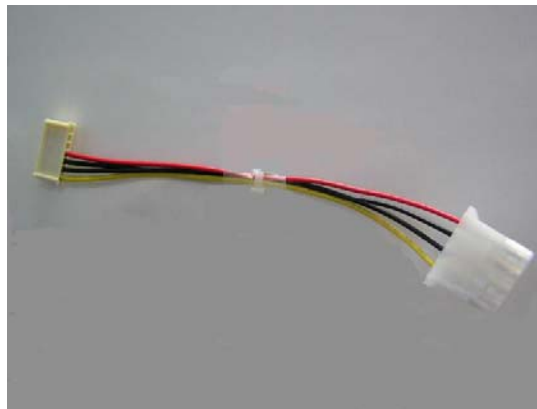
Intel has identified that some Intel Server Chassis SR2400 Tape Drive Accessory kits (ADRTAPEKIT ), with a manufacturing pack date of 14 Sept 04 or earlier, were assembled and shipped with no Tape Drive Power Cable. The cable is used to direct power from either a SCSI or SATA Backplane to the Tape Drive.

The manufacturing Pack Date can be found on the white product label affixed to the kit's outer packaging.

An off the shelf power extension cable connected to the 4-pin power supply power cable labeled P5 can be used to power a tape drive.

All product with a manufacturing Pack Date of 15 Sept 04 or later have either been reworked or originally assembled to include the missing cable.

Customers that find that they have Tape Drive Kits with the missing power cable should get replacement product using the standard RMA process.
