# intel® Technical Advisory

TA-0680-1

December 5, 2003

## Intel® Server Board S875WP1-E: Two Capacitors May Prevent Installation of Boxed Intel® Processor Fan Heatsink.

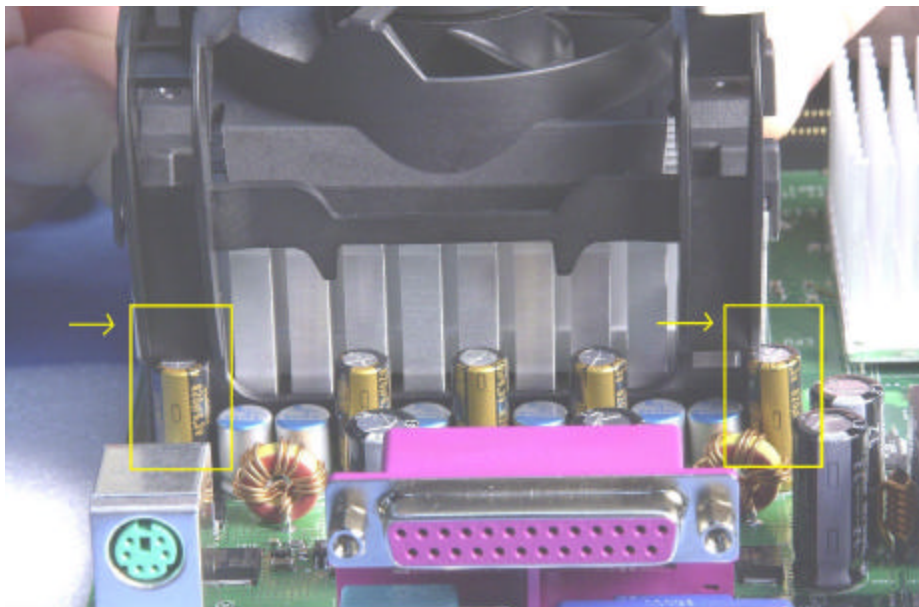
Intel® Server Board S875WP1-E, AA# CXXXXX-304, were built with two capacitors at locations C1C4 and C3C1 near the processor retention mechanism. These locations should not have been populated with capacitors. The height of the capacitors at locations C1C4 and C3C1 may prevent the fan heatsinks included with Intel boxed processors supported by server board S875WP1-E from being installed (see photo below).

Capacitors were utilized at locations C1C4 and C3C1 for builds of server board S875WP1-E with AA# CXXXXX-304 due to a Bill of Material (BOM) markup error.

An ECO has been released which removes the capacitors from locations C1C4 and C3C1. This ECO will result in server board S875WP1-E PBA to be changed to AA# CXXXXX-305. This ECO was implemented on 12/2/03

If your Intel Server Board S875WP1-E, AA# CXXXXX-304, exhibits the described mechanical interference issue, please contact Intel for a replacement board using Intel's warranty process. You will need to reference TA-0680-1 when you call.
