# intel® Action Alert

AA-0747-2 (Update)

February 10, 2005

## Intel® Server Board SE7520BD2 – Heat Sink Fastener Pins Not Fully Inserted

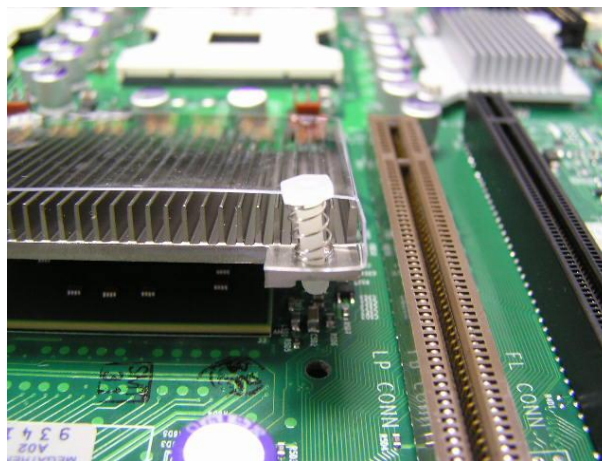
Intel has recently been made aware of an issue with some SE7520BD2 server boards where a heat sink retention pin was found disengaged causing the affected heat sink to move from its required position.

Through factory process inspection, Intel has determined that inconsistent pressure was being used to insert the heat sink retention pins from one board to the next. Retention pins that were not fully inserted into the baseboard did not have their tabs fully expanded allowing for potential disengagement during shipping due to excessive shock or vibration.

Intel recommends that customers with in-house inventories that fall within the specified board serial number range visually screen for possible heat sink pin disengagement and manually check that all heat sink pins are fully engaged. Based on the visual screen results, Intel recommends the following:

- 1) If a heat sink is found to be fully removed from the baseboard, Intel recommends that the board be returned using the standard RMA process. These boards have a potential of other component damage due to heat sink contact during shipping.

- 2) If a single heat sink retention pin has disengaged and the heat sink has pivoted from its normal position, Intel recommends that the components around the affected heat sink be visually inspected for damage. If no damage is found, the heat sink can be moved back to its normal position and the loose pin pushed down into place far enough to have its tabs spread open under the baseboard. If component damage is found, the board should be returned using the standard RMA process.

- 3) If a heat sink pin has disengaged but the heat sink is still in its normal position over the chip, Intel recommends that the pin be pushed back down far enough to have its tabs spread open underneath the baseboard.

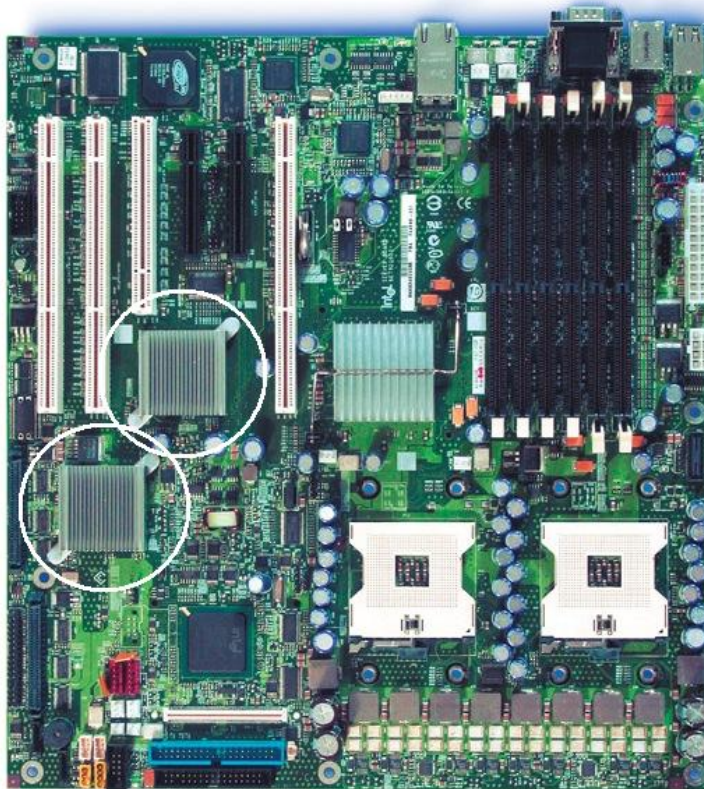
As shown in the following photograph, the Intel Server Board SE7520BD2 has two on-board heat sinks that may be affected by this issue.

Note: SATA only versions, of the SE7520BD2, will only have one affected heat sink. The upper heat sink as pictured above.

For affected products stocked in its warehouses the week of January 17, 2005, Intel has inspected, and where necessary reworked, all boards. All new builds starting from January 18<sup>th</sup>, 2005 and going forward will have heat sinks mounted using a new process including an end of line visual inspection. Boards assembled with the new process will have a serial number starting at BZBD504xxxxx.
